**REPORT
PRELIMINARY
GEOTECHNICAL INVESTIGATION
PARCELS PP-46-A AND PP-46-C
2854 AND 2952 WEST RASMUSSEN ROAD
SUMMIT COUNTY, UTAH**

Job No. 278-004-16

Gordon Geotechnical Engineering, Inc.

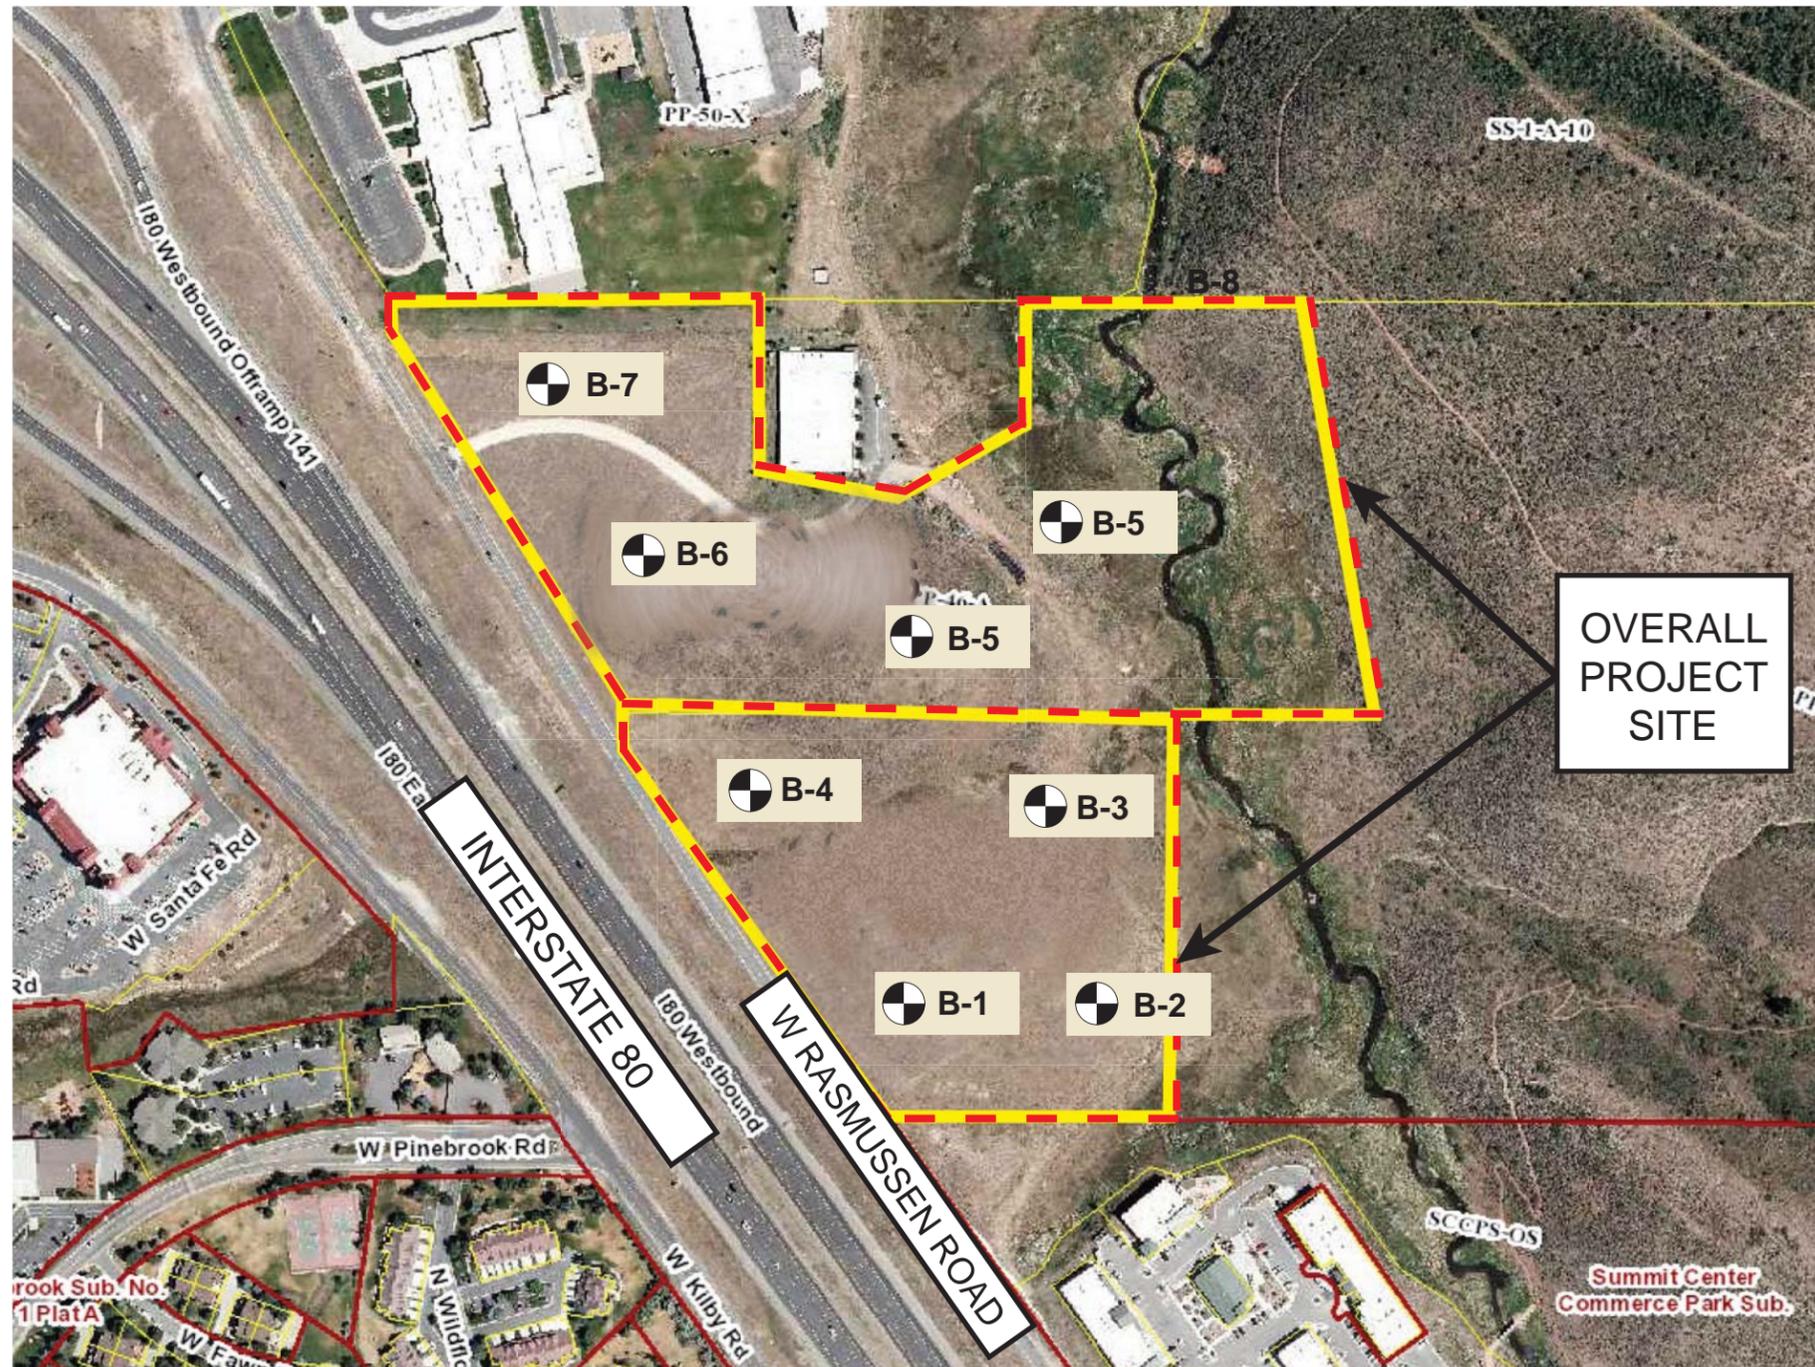
↑
FIGURE 3
SITE PLAN

In order to define and evaluate the subsurface soil and groundwater conditions at the site, 8 borings were explored to depths of 9 to 21 feet below existing grade. The borings were drilled using a truck-mounted drill rig equipped with hollow-stem augers. Locations of the borings are presented on Figure 3.

This report presents the results of our preliminary geotechnical investigation performed at Parcels PP-46-A and PP-46-C which is located at 2854 and 2952 West Rasmussen Road in Summit County, Utah. The general location of the site with respect to major topographic features and existing facilities, as of 1998, is presented on Figure 1, Vicinity Map. A detailed location of the site showing existing roadways and surrounding facilities, on an air photograph base, is presented on Figure 2, Area Map. A more detailed layout of the site showing the proposed structures and roadways is presented on Figure 3, Site Plan. The locations of the borings drilled in conjunction with this study are also presented on Figure 3.

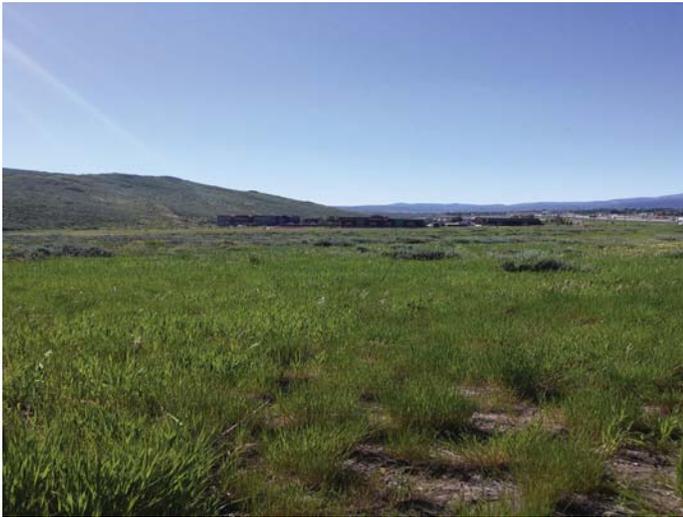
#1 Facing southeast across the southern parcel.

Representative photographs of the site area are shown on Figure 6, Photographs.

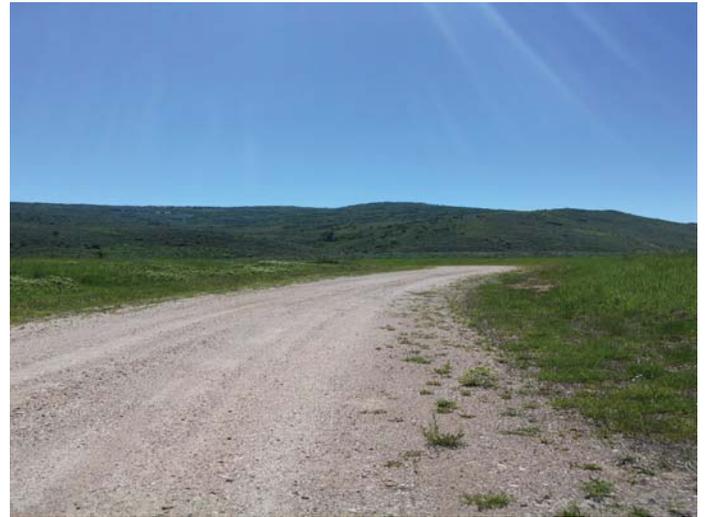
#2 Facing east across the northern parcel, along the water plant access road.

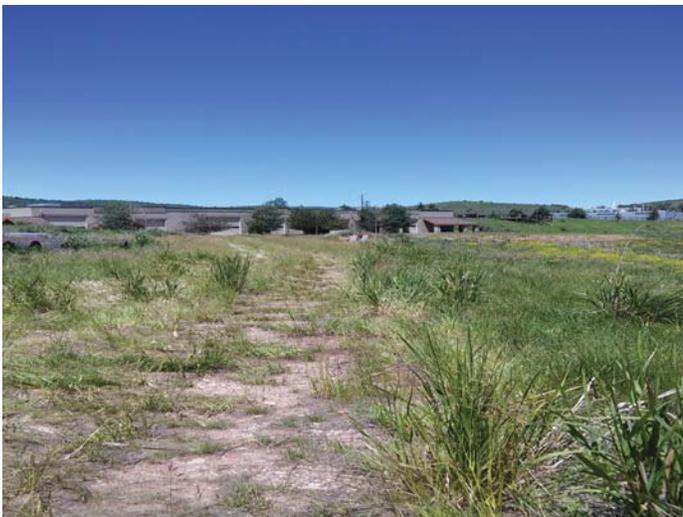
#3 Facing northwest toward the water plant.

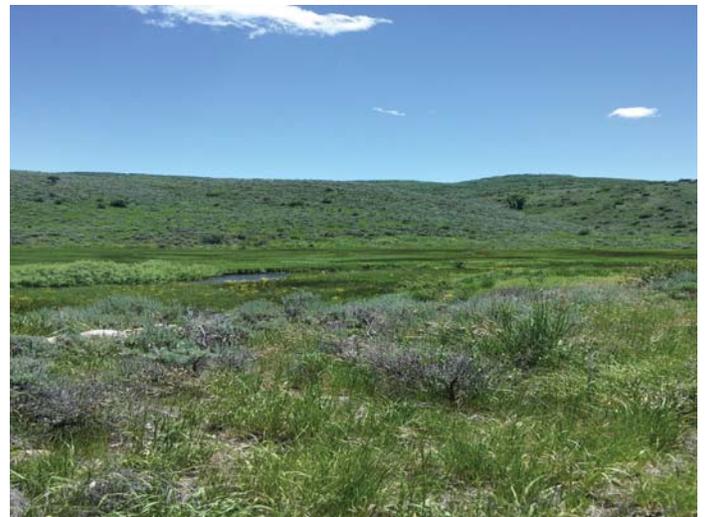
#4 Facing east toward the creek.

The topography of the site is undulating with several small hills and drainages. Overall the topography slopes down to the east with a total relief of approximately 20 to 30 feet across the site. A drainage with heavy vegetation suggesting a shallow water table extends from west-to-east across the central portion of the site.
